**FOURTH FIVE-YEAR REVIEW REPORT FOR
HI-MILL MANUFACTURING COMPANY
HIGHLAND TOWNSHIP
OAKLAND COUNTY, MICHIGAN**

**U.S. Environmental Protection Agency
Region 5
Chicago, Illinois**

2015

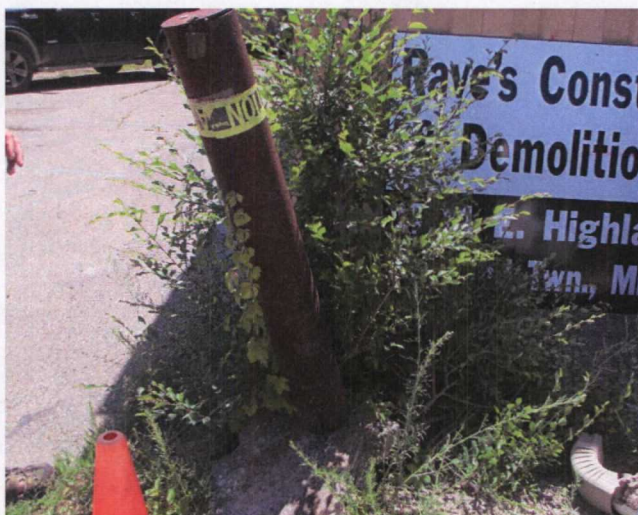
Compromised
monitoring well (MW21)
outside of warehouse.

OU(s): 01/Sitewide	Issue Category: Operations and Maintenance			
	Issue: The integrity of some of the groundwater monitoring wells appears to be compromised.			
	Recommendation: Evaluate all groundwater monitoring wells to determine which wells need to be retained, re-developed, or formally abandoned per State regulations. Evaluate whether new monitoring wells should be installed.			
Affect Current Protectiveness	Affect Future Protectiveness	Party Responsible	Oversight Party	Milestone Date
No	Yes	EPA	EPA/State	11/30/2015

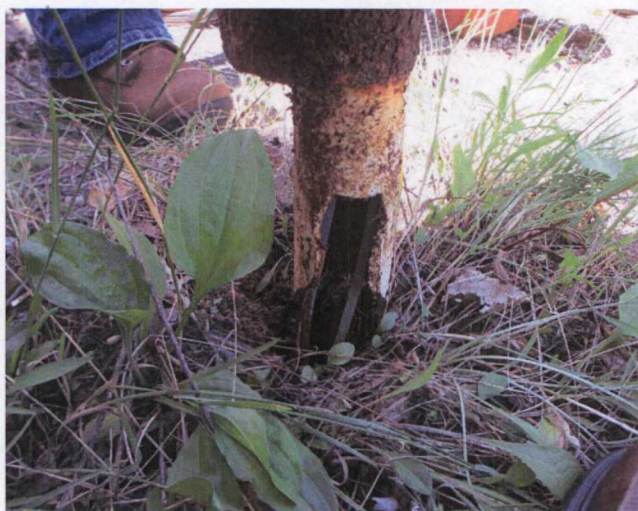
Compromised
monitoring well (SW3),
broken at base, tubing
visible.

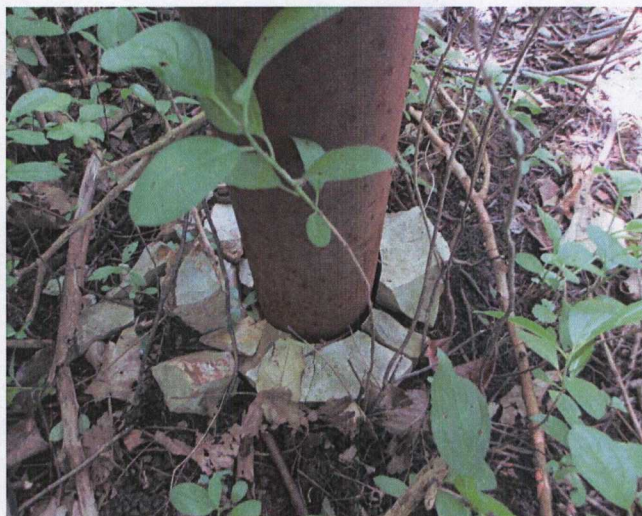
Monitoring well
(SW12) with
compromised base.

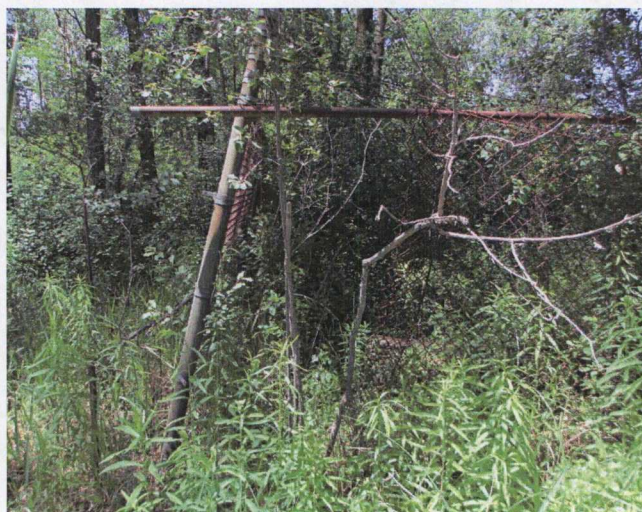
Damage to perimeter
fence.

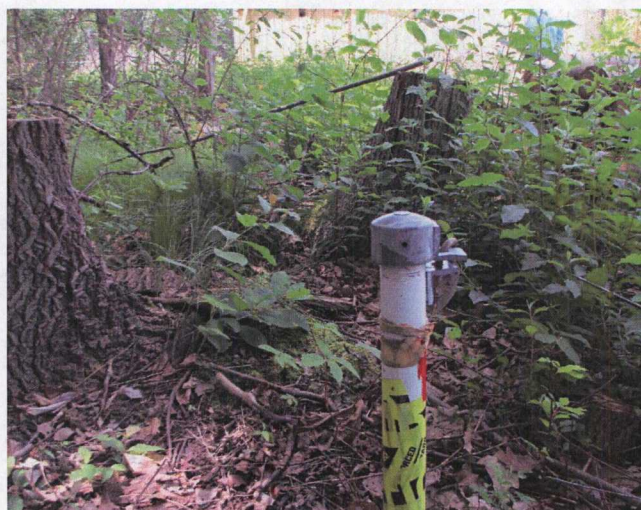
Unlabeled monitoring
location.

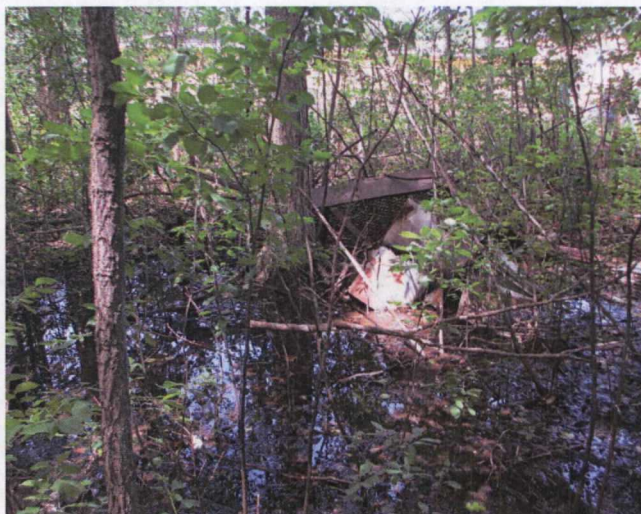
General debris and standing water near monitoring well (IW2).

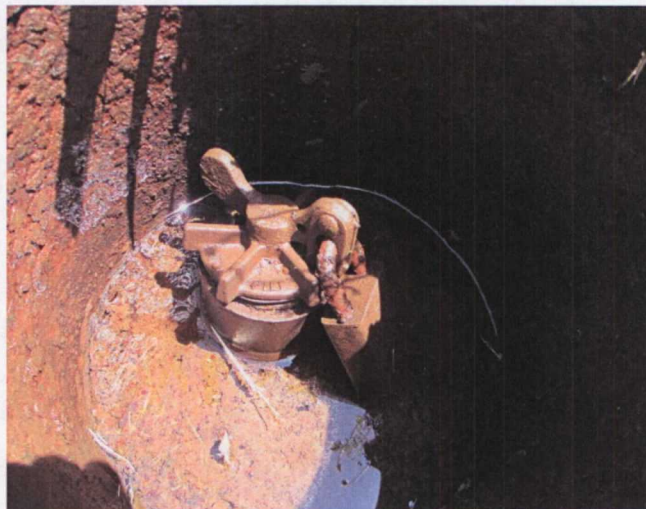
Standing water in flush
mount monitoring well
in highway median.

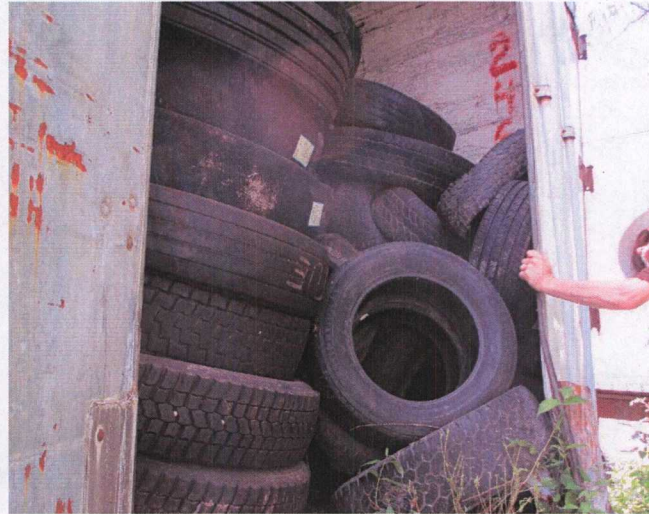
Abandoned trailer on parking lot filled with tires.

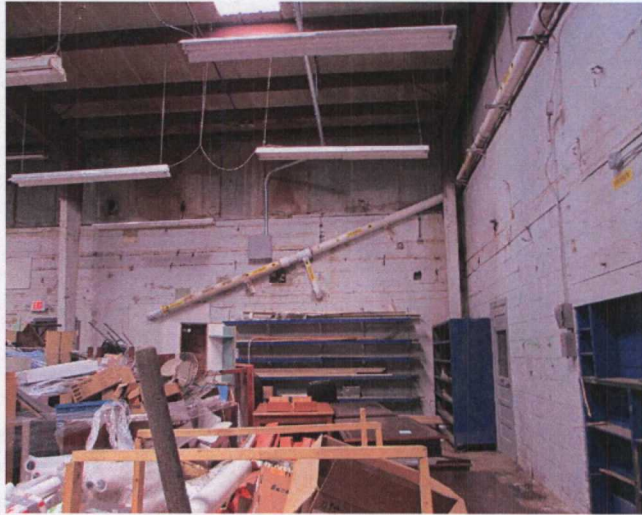
Subsurface
Depressurization System
piping along wall in
warehouse.

OU(s): 01/Sitewide	Issue Category: Changed Site Conditions			
	Issue: The Agencies need to determine whether additional follow-up activities are needed to address the vapor intrusion pathway for on-site workers.			
	Recommendation: Review the design specifications of the newly-installed vapor mitigation system (Subsurface Depressurization System) in the on-site structures to determine whether additional follow-up activities are needed. Include a routine check of the system as part of Site O&M activities.			
Affect Current Protectiveness	Affect Future Protectiveness	Party Responsible	Oversight Party	Milestone Date
No	Yes	EPA	EPA/State	5/30/2016

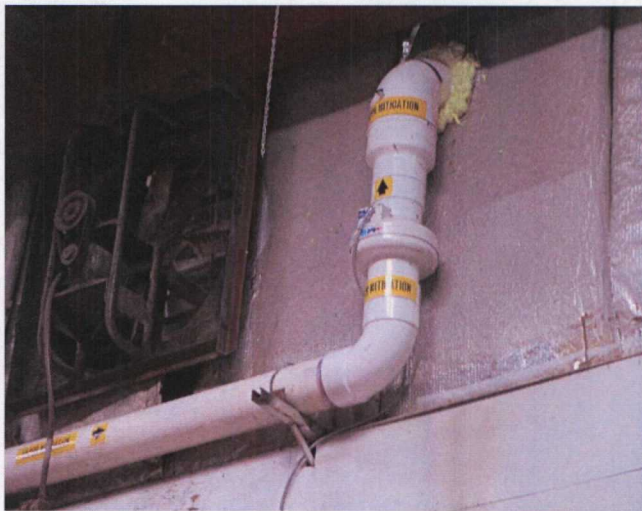
Subsurface
Depressurization System
venting through roof in
warehouse.

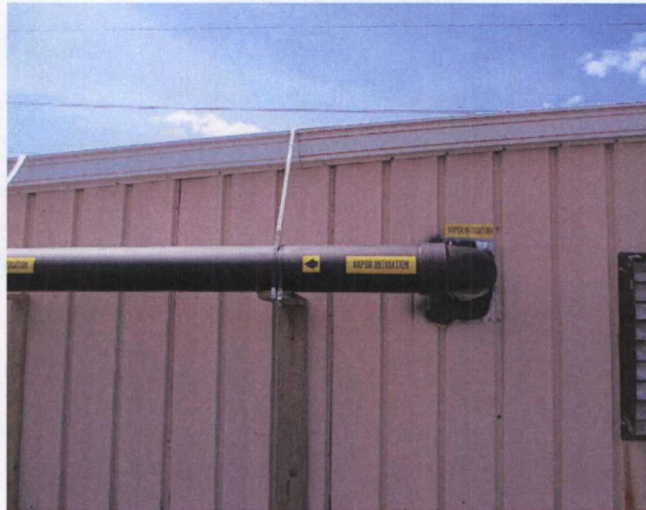
Venting Subsurface
Depressurization System
on roof of warehouse.

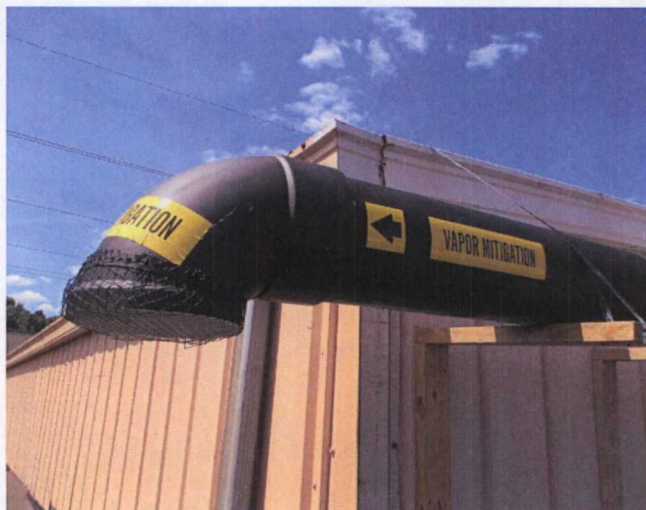
Subsurface
Depressurization System
venting on roof of
warehouse.

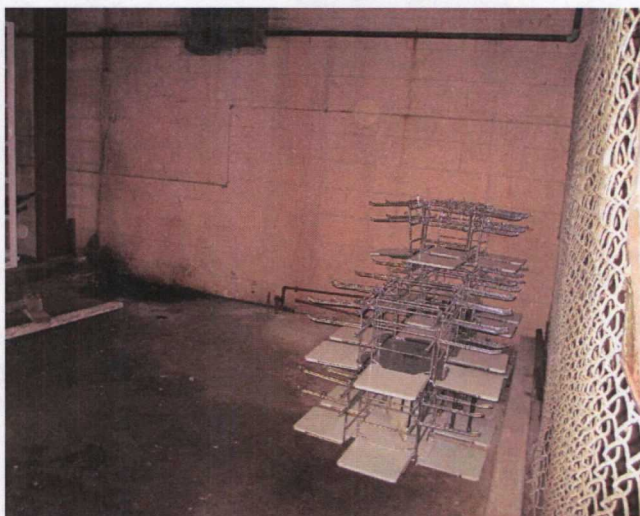
Some staining on floor
of warehouse.
